MEASUREMENT AND ANALYSIS OF BIOACOUSTIC ENVIRONMENTS ABOARD AC-119G AND AC-130A GUNSHIPS

JUSTUS F. ROSE, JR., MAJOR, USAF

SEPTEMBER 1969

AEROSPACE MEDICAL RESEARCH LABORATORY
AEROSPACE MEDICAL DIVISION
AIR FORCE SYSTEMS COMMAND
WRIGHT-PATTERSON AIR FORCE BASE, OHIO

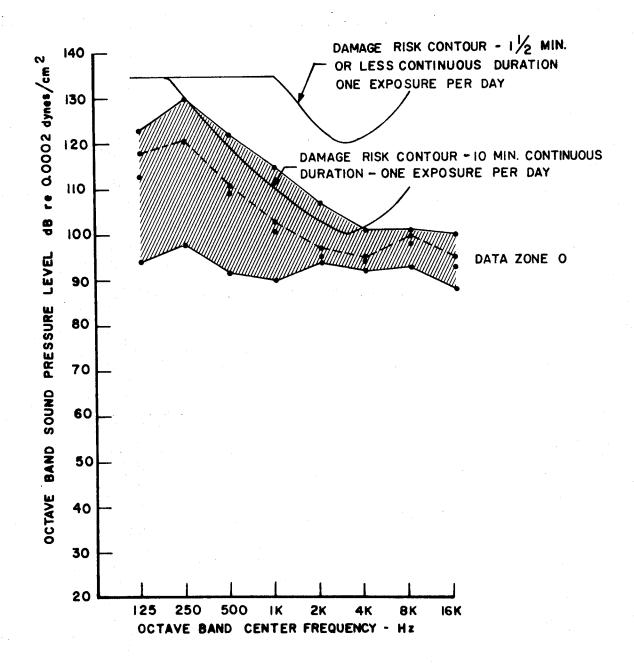
Figure 7. AC-119G Sound Pressure Levels In Cargo Compartment During Taxi, Take-Off, and Climb

Plotted in conjunction with the data zone is the damage risk contour for a 1½ minute or less continuous duration — one exposure per day. This criteria can be applied to the take-off condition which is the upper limit of the data zone. In figure 7 none of the data points are above the contour and hence do not constitute a potentially unsafe condition. Also plotted is the damage risk contour for a 10-minute continuous exposure — one exposure per day. This criteria can be applied to the METO climb condition shown by the dotted line in the data zone. Again none of the data points are above the contour and no potentially unsafe condition exists.

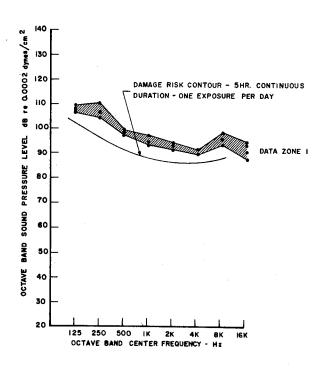
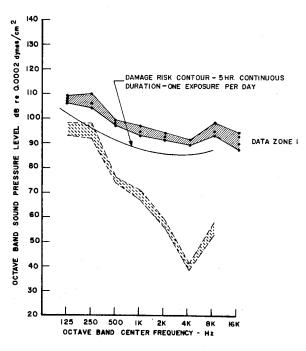
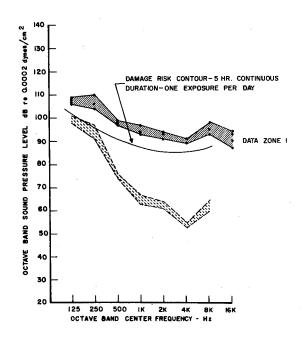
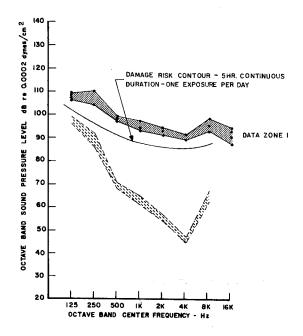
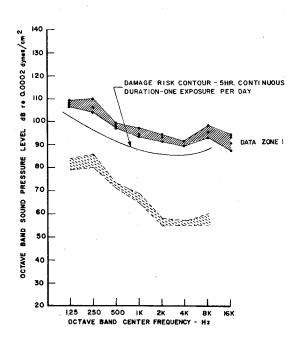
Figure 8. AC-119G Sound Pressure Levels In Cargo Compartment During Cruise — GTPU Operating (1430 BHP, 2100 RPM, 3000 Feet PA)

Plotted in conjunction with the data zone in figure 8a is the damage risk contour for a 5-hour continuous duration — one exposure per day. Based on information obtained at Lockbourne AFB, Ohio, the 5-hour mission is a realistic operational figure. In figure 8a all of the data points are above the contour and hence constitute a potentially unsafe condition. Figures 8b, 8c, 8d, and 8e show the data zone attenuated by four in-service protective devices; a Gentex HGU 2A/P Protective Helmet with Gentex ear cups, an H-157 Headset-Communication unit, Flents disposable ear plugs and V-51R ear plugs. The attenuated data zones show the SPL at the ear under the protective device, and the attenuation values used are the average attainable for each octave band assuming that the device is properly fit in or over the ear.

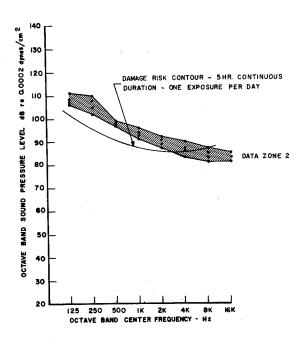
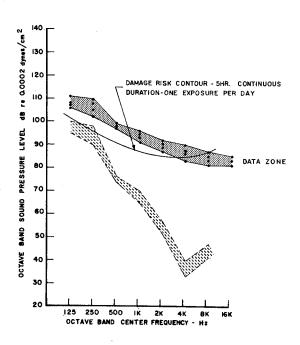
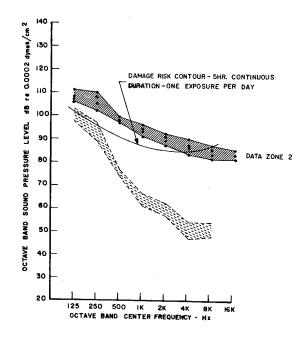
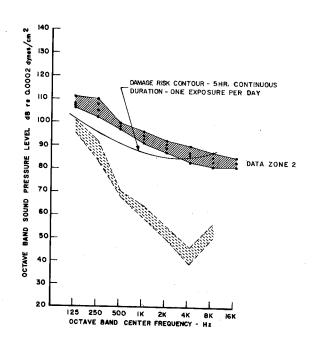
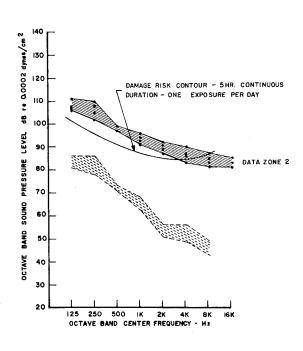
Figure 9. AC-119G Sound Pressure Levels In Cargo Compartment During Cruise — GTPU Off (1430 BHP, 2100 RPM, 3000 Feet PA)

Plotted in conjunction with the data zone in figure 9a is the damage risk contour for a 5-hour continuous duration — one exposure per day. In the figure a majority of the data points are above the contour and hence constitute a potentially unsafe condition. Figures 9b, 9c, 9d, and 9e show the data zone attenuated by four in-service protective devices. The attenuated data zones show the SPL at the ear under the protective device and are valid only if the protective device is fit properly in or over the ear.

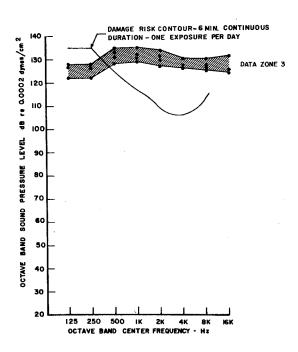
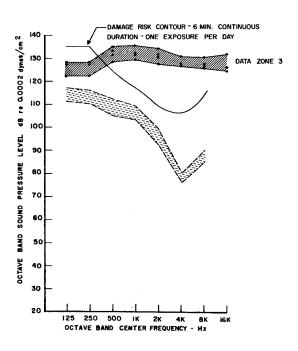
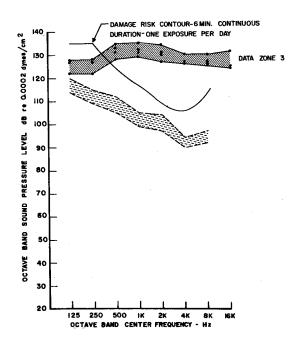
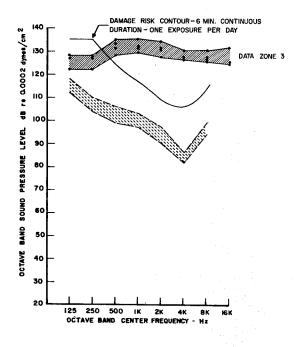
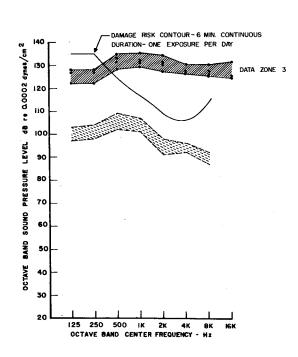
Figure 10. AC-119G Sound Pressure Levels In Cargo Compartment During Gunfiring

Plotted in conjunction with the data zone in figure 10a is the damage risk contour for a 6minute continuous duration - one exposure per day. The 6-minute figure was arrived at by determining the amount of time required to fire out all the 7.62 mm ammo that is carried on the aircraft. Other pertinent comments regarding the selection of the 6-minute continuous duration damage risk contour are contained in the Damage Risk Criteria section. Figures 10b, 10c, 10d, and 10e show the data zone attenuated by four in-service protective devices. The attenuated data zones show the SPL at the ear under the protective device and are valid only if the protective device is fit properly in or over the ear.

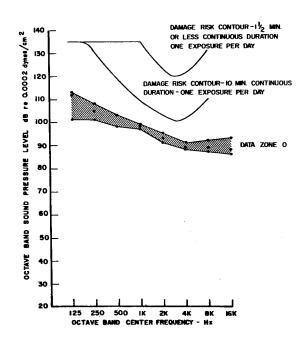
Figure 11. AC-130A Sound Pressure Levels In Forward Compartment During Taxi, Take-Off, and Climb

Plotted in conjunction with the data zone is the damage risk contour for a 1½ minute or less continuous duration — one exposure per day. This criteria can be applied to the take-off condition. Also plotted is the damage risk contour for a 10-minute continuous exposure — one exposure per day. This criteria can be applied to the climb condition. As can be seen from figure 11, none of the data points are above either of the damage risk contours, and no potentially unsafe condition exists.

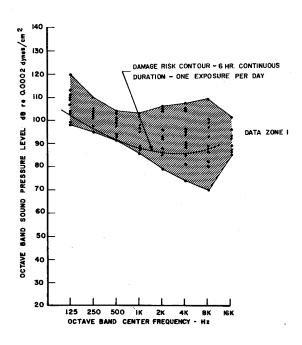
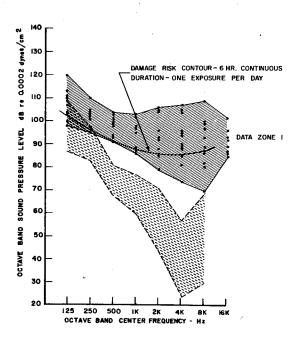
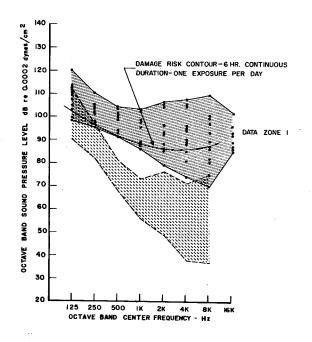
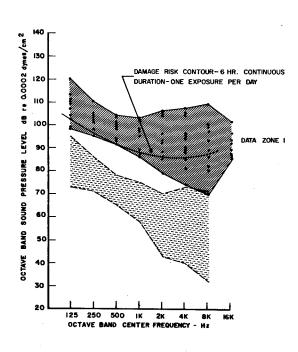
Figure 12. AC-130A Sound Pressure Levels During Cruise (150 KIAS, 2500 Feet PA)

Plotted in conjunction with the data zone is the damage risk contour for a 6-hour continuous duration — one exposure per day. In figure 12a a majority of the data points are above the contour and hence constitute a potentially unsafe condition. Figures 12b, 12c, 12d, and 12e show the data zone attenuated by four in-service protective devices; a Gentex HGU 2A/P Protective Helmet with Gentex ear cups, an H-157 Headset Communication Unit. Flents disposable ear plugs and V-51R ear plugs. The attenuated data zones show the SPL at the ear under the protective device, and the attenuation values used are the average attainable for each octave band assuming that the device is properly fit in or over the ear.

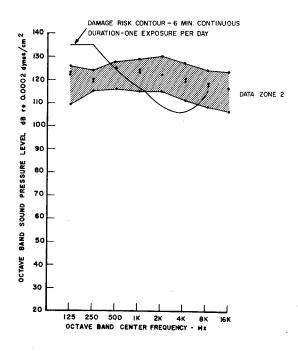
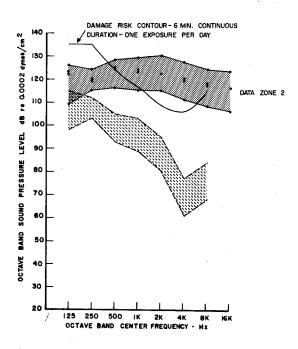
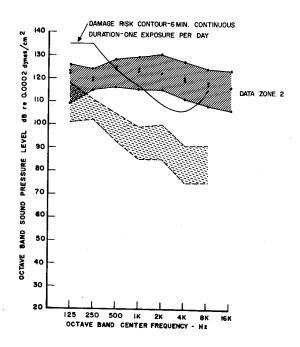
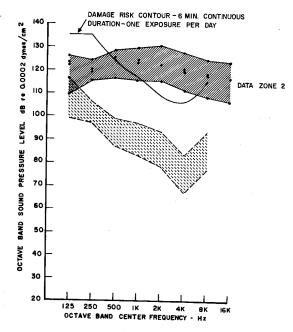
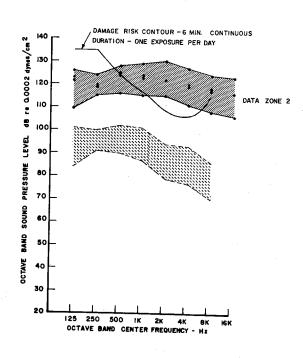
Figure 13. AC-130A Sound Pressure Levels In Aft Compartment During Gunfiring

Plotted in conjunction with the data zone in figure 13a is the damage risk contour for a 6-minute continuous duration — one exposure per day. The 6-minute figure was arrived at by determining the number of rounds of 7.62 mm and 20 mm ammunition that can be carried aboard the aircraft, and knowing the firing rate of the weapons (3000 round/min for the 7.62 mm miniguns and 2500 rounds/min for the 20 mm vulcans), the maximum firing duration can be determined. In figure 13a a majority of the data points are above the contour and hence constitute a potentially unsafe condition. Figure 13b, 13c, 13d, and 13e show the data zone attenuated by the four in-

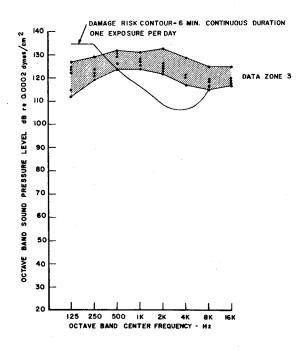
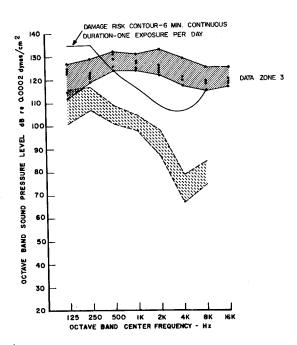
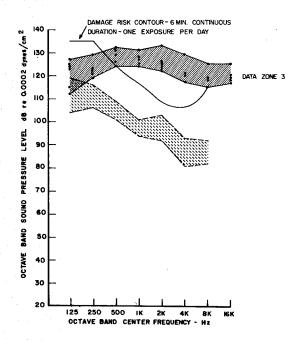
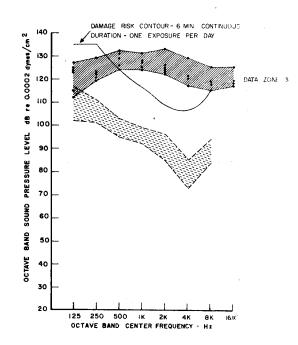
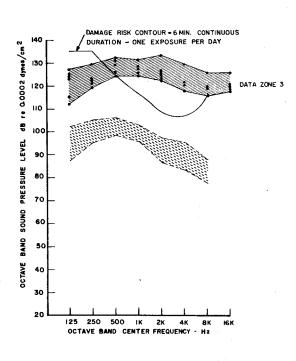
Figure 14. AC-130A Sound Pressure Levels In Forward Compartment During Gunfiring

Plotted in conjunction with the data zone in figure 14a is the damage risk contour for a 6-minute continuous duration—one exposure per day. Figure 14a shows a majority of the data points are above the contour and hence constitute a potentially unsafe condition. Figures 14b, 14c, 14d, and 14e show the data zones attenuated by four in-service protective devices. The attenuated data zones show the SPL at the ear under the protective device and are valid only if the protective device is fit properly in or over the ear.
